## ENGINEERING ANALYSIS CLOSING REPORT

**SUBJECT:** Brake pipe corrosion failures in model year (MY) 1999 through 2003 General Motors GMT800 series pickup trucks (Figure 1) and sport utility vehicles (Figure 2) in salt states.

**EA No.:** EA11-001

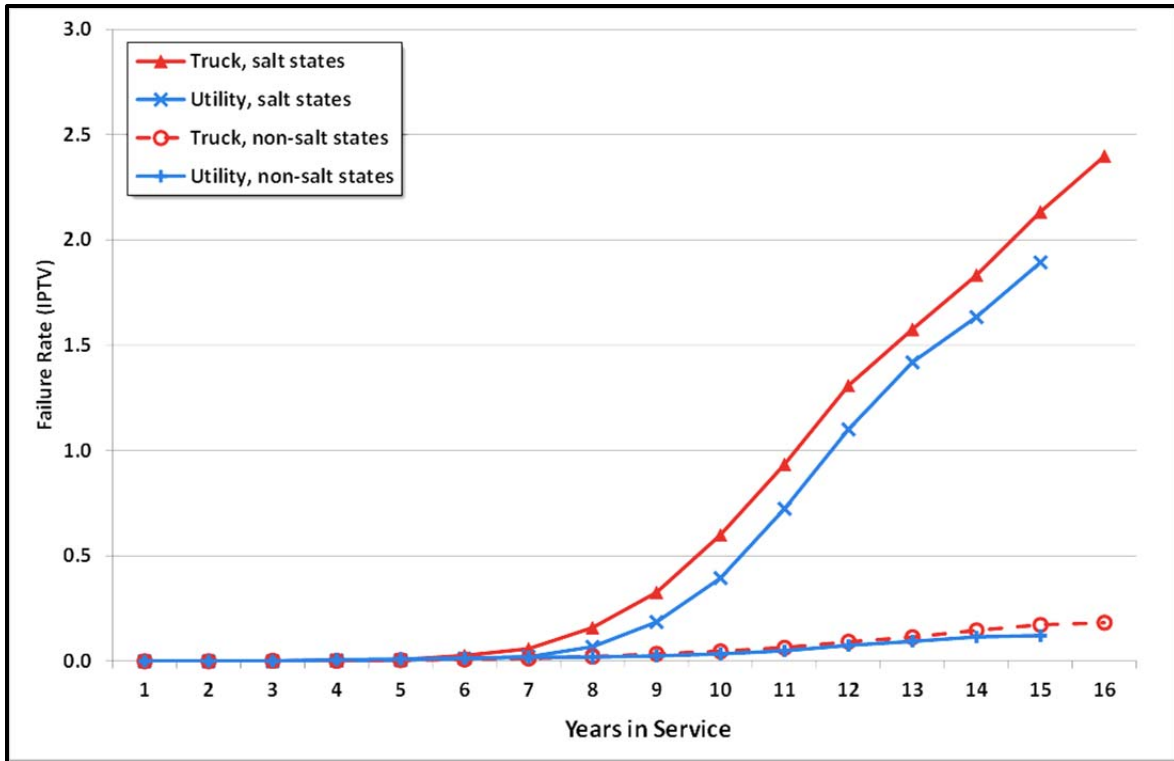
**Figure A5. Cumulative Hazard Plot Of Brake Pipe Leak Complaints by Vehicle Type, Region and Years in Service (MY 1999-2003 GMT800 Vehicles).**

Overall analysis of the complaint rate by vehicle age for salt states and non-salt states shows failure experience begins to develop in the salt states after approximately 7 years in service as shown in Figure A5 in the Appendix. By the 12th year of service, the complaint rates have exceeded 1.0 IPTV for both the subject pickup trucks and utility vehicles.

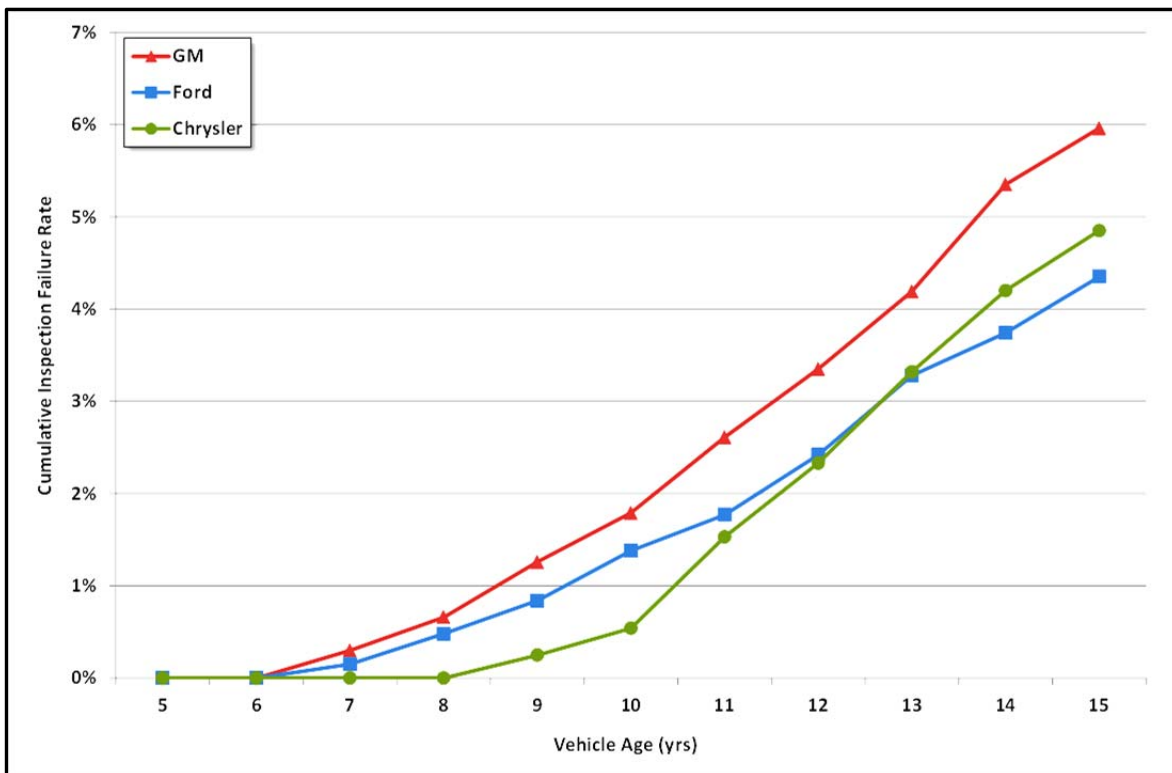
**Figure A6. Cumulative Brake Pipe Inspection Failure Risk by Vehicle Age for MY 1999-2003 Full-Size Pickup Trucks, PennDOT E-SAFETY Data from CY 2008-2014 Inspections.**

ODI's analysis of the PennDOT e-SAFETY data by vehicle age for GM, Ford and Chrysler full-size pickup trucks is shown in Figure A6 in the Appendix. The chart shows the cumulative risk of experiencing a brake pipe related inspection failure by the number of years the vehicle had been in service. Similar to the complaint rate analysis by vehicle age shown in Figure A5, the PennDot data shows that the GM risk for inspection failure is low for the first 7 years of service. After 10 years in service the GM vehicles have about a 1.8 percent chance of having failed an annual inspection. In comparison, the inspection failure rates at 10 years in service were 1.4 percent for the Ford peer trucks and 0.5 percent for the Chrysler peer trucks. The inspection failure rates increase for all three manufacturers after 10 years in service, with all three having more than a 2 percent chance of experiencing an inspection failure by 12 years in service and more than a 3 percent chance by 13 years in service.

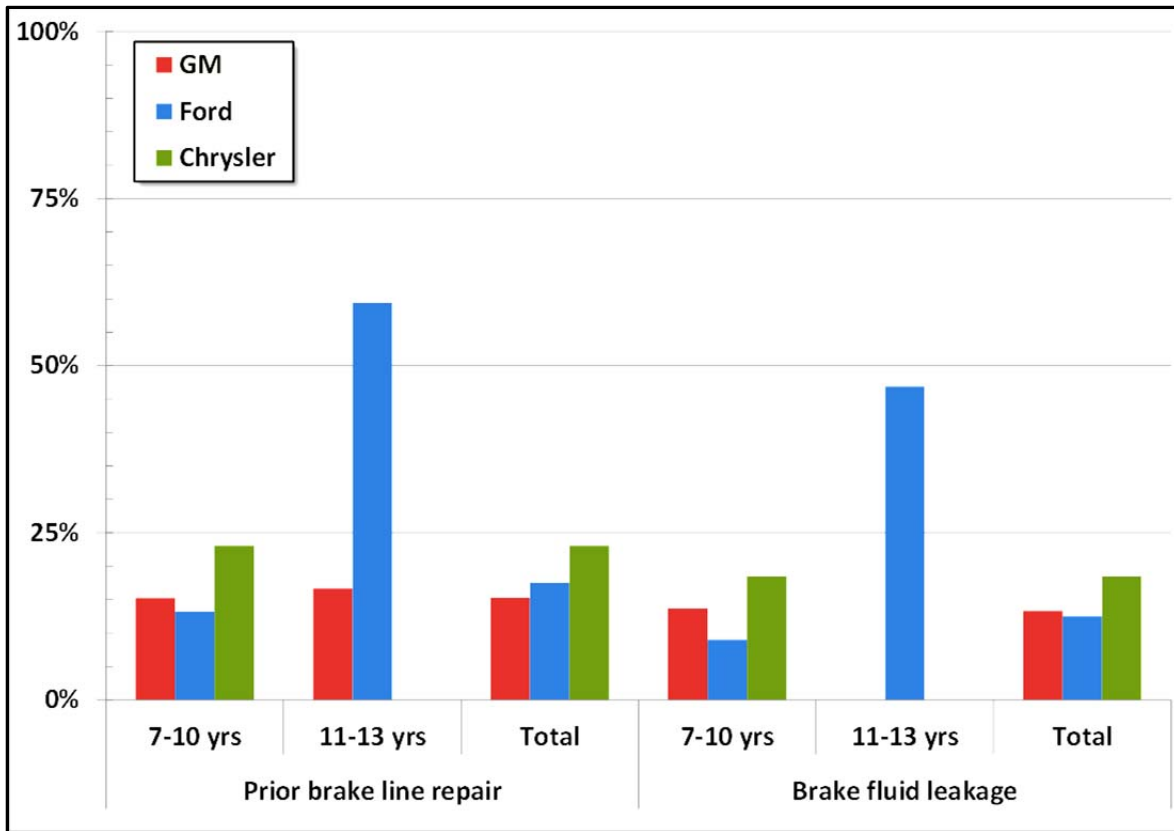
Figure A7. VRTC survey results by vehicle age, MY 1999-2003 full-size pickup trucks.

ODI conducted an additional analysis to account for vehicle age as a factor in the survey results. The analysis showed similar rates for each manufacturer for vehicles with 10 years or less of service and higher rates for each manufacturer for vehicle more than 10 years old (Figure A7). These results indicate substantially higher rates of pipe failure/repair through 10 years of service (10 to 23 percent) than the subject vehicle complaints (less than 0.1 percent) or PennDOT e-SAFETY data (1 percent).

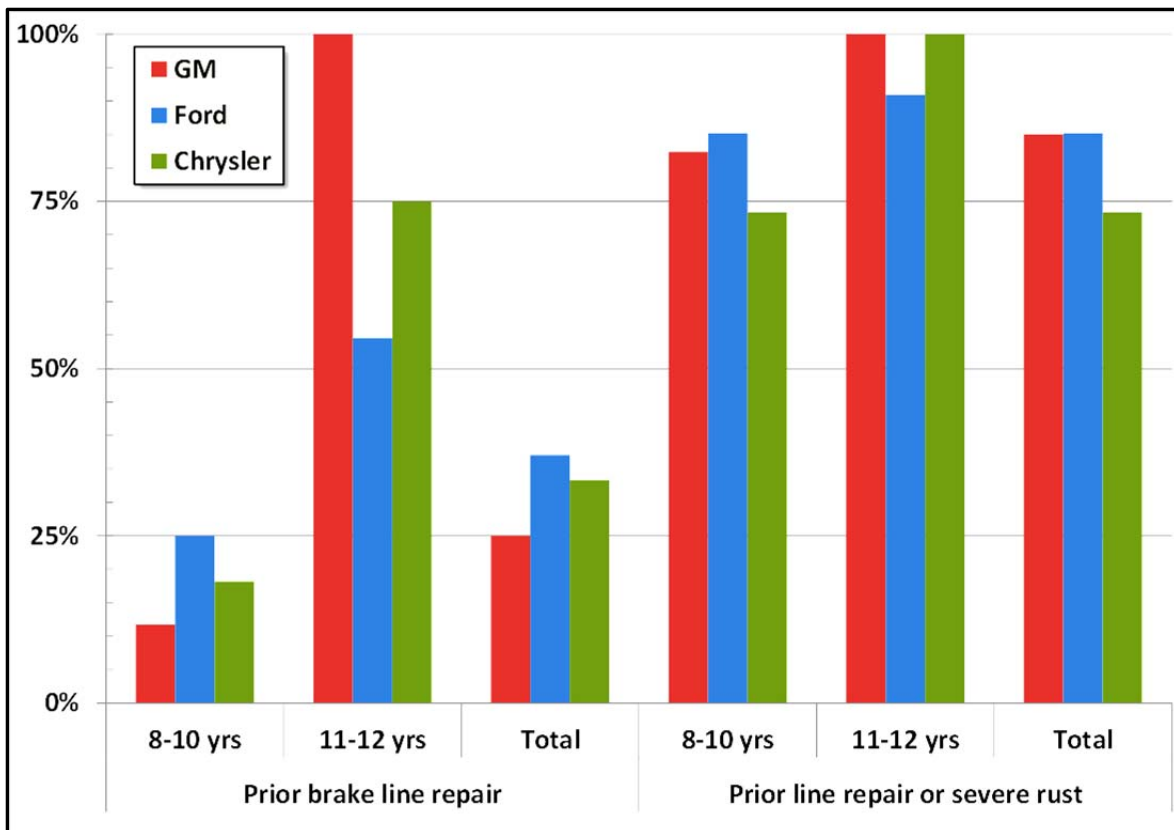
Figure A8. Combined Inspection Results by Vehicle Age, MY 1999-2003 Full-Size Pickup Trucks.

**Vehicle Inspections:** During PE10-010 and EA11-001, NHTSA and GM engineers inspected brake pipes in 71 randomly selected MY 1999 through 2003 subject and peer vehicles (Ford and Chrysler full-size pickup trucks) located in salt states with high use of road salts for deicing, including the Boston and Buffalo metropolitan areas and various locations in Maryland and Ohio. Some of the inspections were conducted independently and some jointly. The vehicles ranged from 8 to 12 years in age and from 49,859 to 248,619 miles of use. The average mileage was 123,582 miles and the median mileage was 120,729 miles. The combined results of all such inspections are summarized in Figure A8 in the Appendix.

The brake pipes were inspected to determine if there had been a prior repair and the areas of most severe brake pipe corrosion were ranked on a scale from 1 to 10. Vehicles with no visible brake pipe corrosion were given the highest ranking (10) and vehicles with at least one brake pipe leaking or previously repaired/replaced were given the lowest ranking (1). Vehicles with scaling/flaking corrosion indicating onset of metal loss were given the second lowest ranking (2). The inspections found similar results for each manufacturer, with vehicle age a significant factor in the likelihood of having a prior brake pipe repair and for exhibiting severe flaking corrosion of some section of brake pipes.

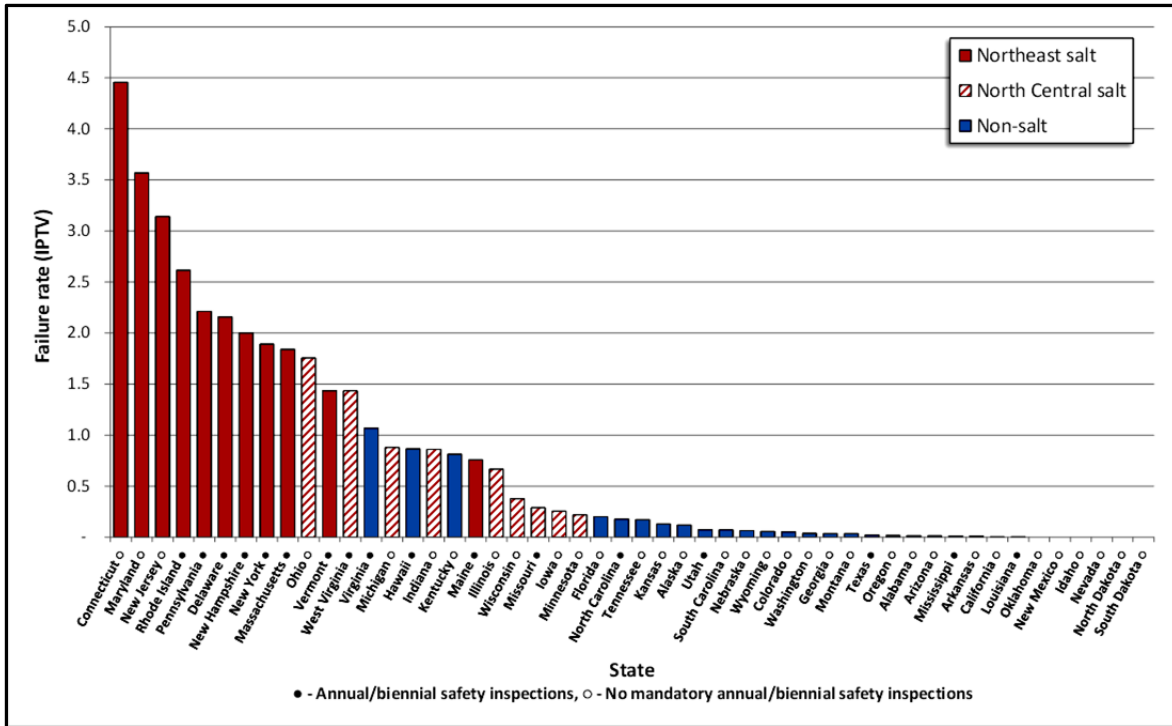
Figure A9. Failure Rate by State, MY 1999-2003 GMT800 Vehicles.

**Field Data Analysis by Region.** Failure rates by state are shown for subject vehicles in Figure A9 in the Appendix. The analysis shows a significant difference between Northeastern and North Central salt states, with many of the latter experiencing rates comparable to non-salt states. Most of the Northeastern states require safety inspections every one or two years. The states without inspection programs (Connecticut, Maryland and New Jersey) had the highest rates, indicating that inspections may be partially helpful in reducing the risk of brake pipe failure. The highest rates for non-Salt states were observed in states bordering the salt states (e.g., Virginia, Kentucky) or coastal states (e.g., Hawaii).

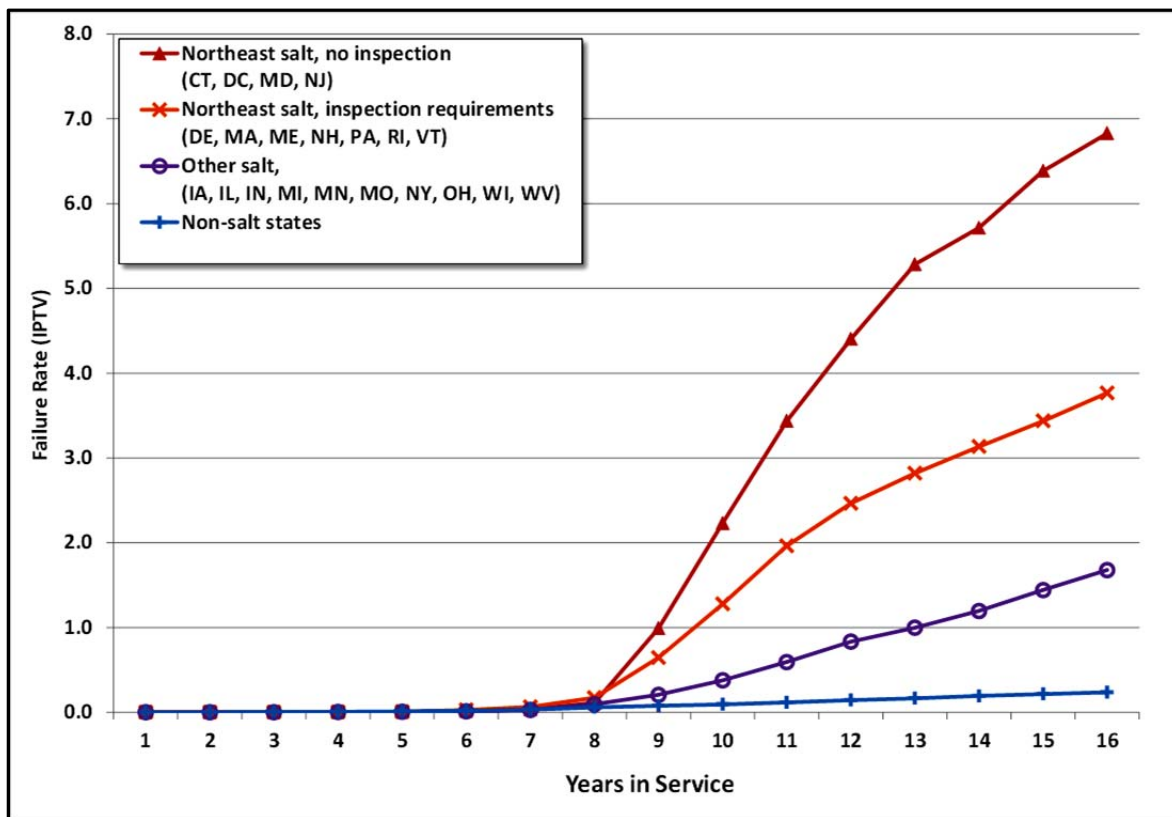
Figure A10. Cumulative Failure Rate by Vehicle Age and Region, MY 1999-2003 GMT800.

Analysis of failure rates by vehicle age and region is provided in Figure A10 in the Appendix. This analysis shows the differences between regions as a function of vehicle age. As noted above, the highest rates are observed in Northeastern states with no mandatory safety inspection programs, followed by Northeastern states with inspection programs.
