## ENGINEERING ANALYSIS CLOSING REPORT

**SUBJECT:** Brake pipe corrosion failures in model year (MY) 1999 through 2003 General Motors GMT800 series pickup trucks (Figure 1) and sport utility vehicles (Figure 2) in salt states.

**EA No.:** EA11-001

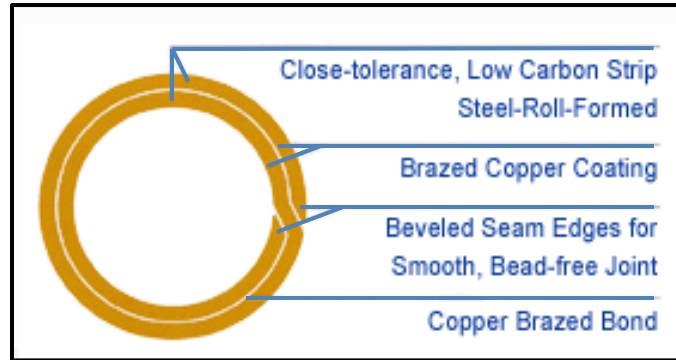
Figure 4. Double-Wall Brake Pipe (TI Automotive).

**Brake Pipe Construction/Coating.** The brake pipes used in the subject vehicles are copper brazed, double-wall steel tubes (Bundy tubes) supplied by TI Automotive. Bundy tubes are manufactured from a low-carbon continuous strip of copper plated cold rolled steel, double wrapped through 720 degrees and brazed (Figure 4).

The steel-copper construction is vulnerable to galvanic corrosion if exposed to the environment. The subject brake pipes use an AlGal coating for protection against corrosion and abrasion. The AlGal coating system consists of a hot-dipped alloy inner sacrificial layer (95% zinc and 5% aluminum Galfan coating) and an aluminum rich paint outer barrier layer (Figure 5). General Motors changed to a NyGal coating system in the GMT900 series vehicles, which were launched in MY 2007. The NyGal coating uses an extruded nylon (PA12) coating for the outer barrier layer instead of the aluminum rich paint (Figure 6). The plastic coating is substantially ( $\approx 50x$ ) thicker and provides a stronger barrier against damage from exposure to tire kick-up (e.g., stone pecking) than the aluminum paint used in the AlGal coating.

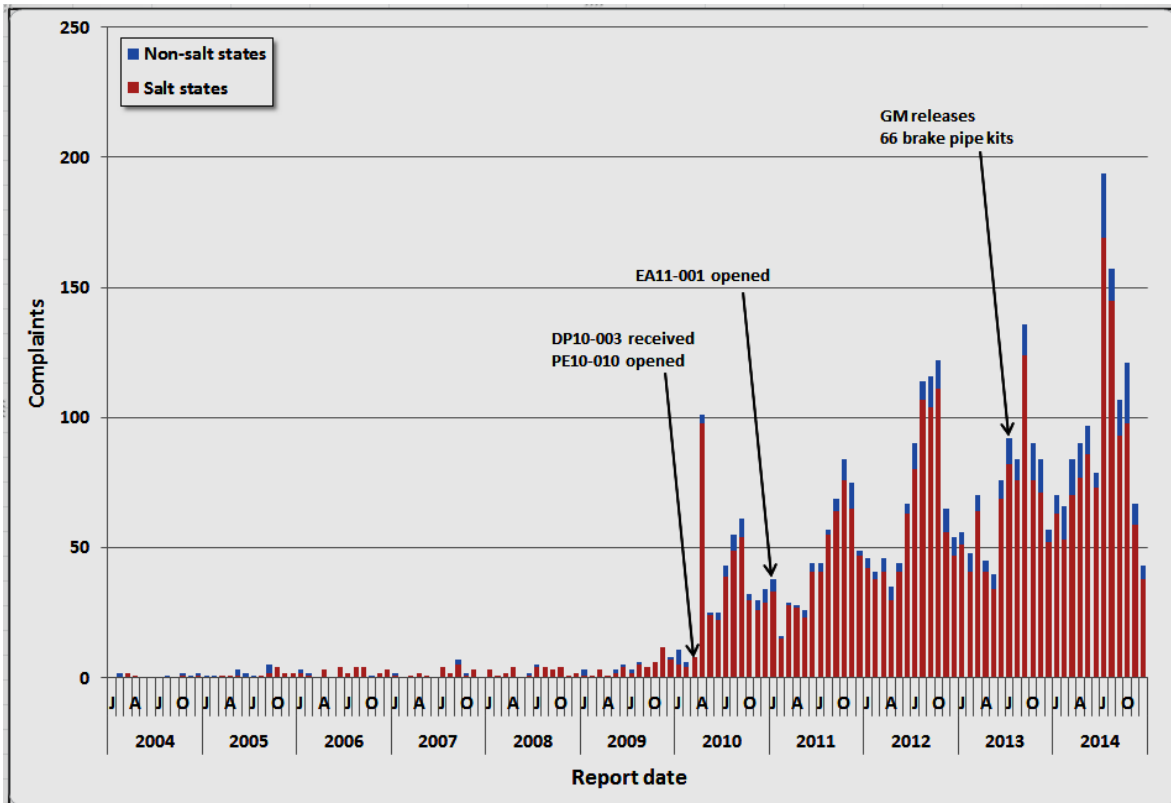
Figure A1. ODI Complaint Trend, GMT800 Brake Lines.

On March 29, 2010, ODI opened Defect Petition DP10-003 to evaluate the petitioner's request for an investigation of brake pipe failures in MY 2003 Chevrolet Silverado 2500HD pickup trucks. The petition was granted on March 30, 2010, and Preliminary Evaluation PE10-010 was opened to investigate corrosion related brake pipe failure in MY 1999 through 2003 General Motors C/K pickup trucks and sport utility vehicles based on 110 complaints, including 3 alleged crashes. After PE10-010 was opened, the number of complaints received by ODI increased from less than 10 per month to 100 in April 2010 (Figures A1 and A2 in the Appendix).

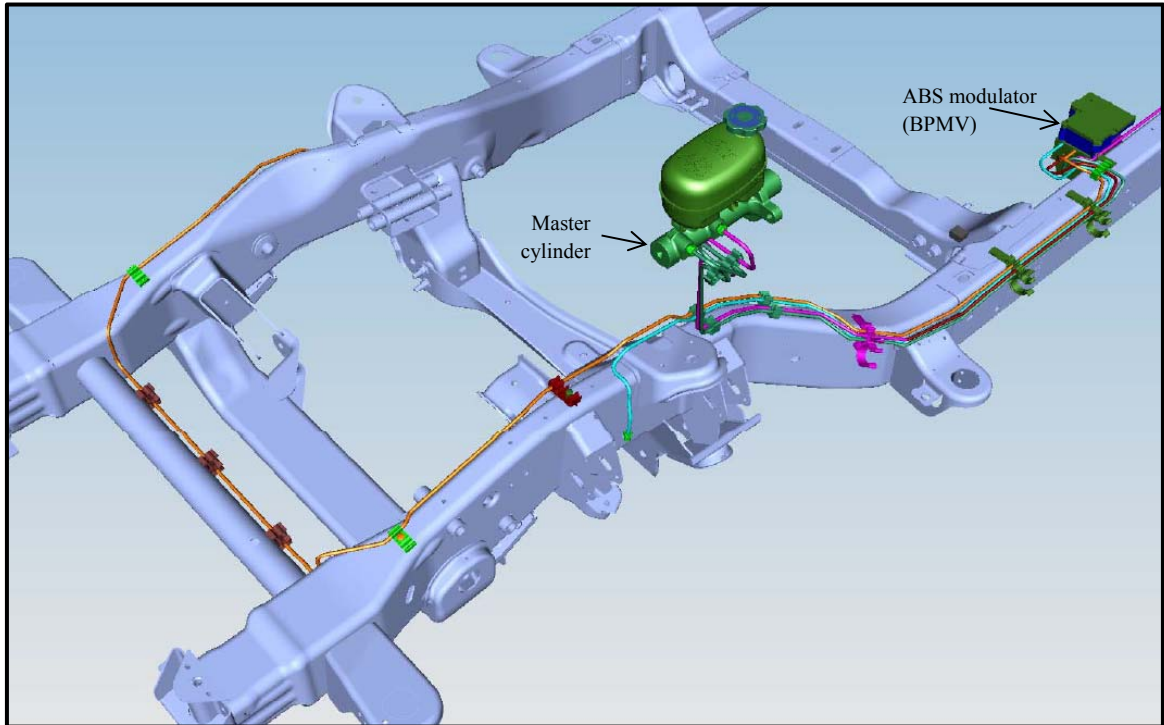
Figure A3. GMT800 Brake Pipe Configuration.

**SYSTEM DESCRIPTION:** The subject vehicles have dual-circuit front-rear split hydraulic service brake systems. There are 66 different brake pipe routing configurations used in the subject vehicles, but all GMT800 vehicles share the same basic brake pipe configuration as shown in Figure A3 in the Appendix. The ABS modulator is located on the in-board side of the left frame rail beneath the driver's seating position. The pipes for the primary (front) and secondary (rear) circuits run from the master cylinder to the front face of the modulator and 3 pipes run from the upper front face of the modulator to the brakes, 2 routed forward to the left and right front brake calipers and 1 routed rearward along the left frame (Figure 3).

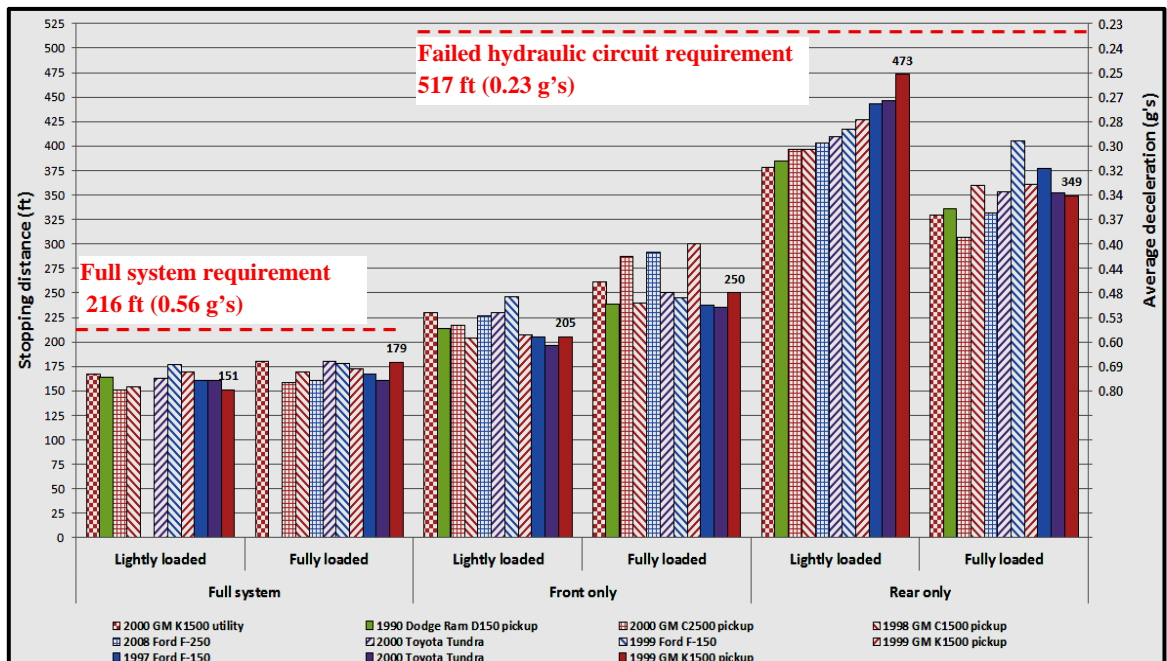
Figure A4. FMVSS 105 Test Results for Full-Size Pickup Trucks and Utility Vehicles.

Prior to MY 2003, when FMVSS 135 became mandatory for GMT800 vehicles with GVWR of 7,716 lbs or less, GM tested the vehicles to the requirements of FMVSS 105. Figure A4 in the Appendix shows the FMVSS 105 full system and partial system failure stopping distance results for the subject vehicles and peers for both lightly loaded and fully loaded test conditions. Partial system failure results are given for both primary (front) circuit failures and secondary (rear) circuit failures.
